FACILITY CONDITION ASSESSMENT

SHERIFF'S OFFICE #5045

106 Edwards Ferry Road

Date of Report: June 25, 2007

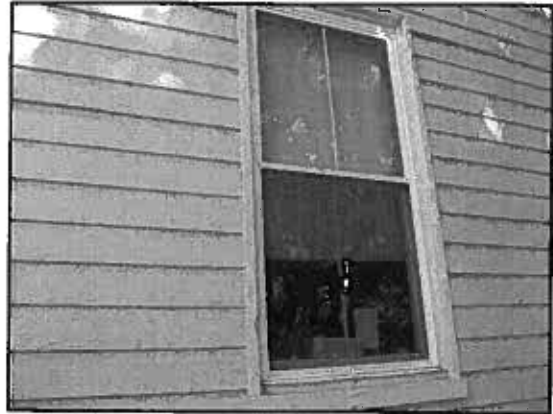
- There is no evidence of window leaks or window condensation. The windows are in good to fair condition and will require routine maintenance during the assessment period.
- The exterior doors and door hardware are in good condition and will require routine maintenance during the assessment period.

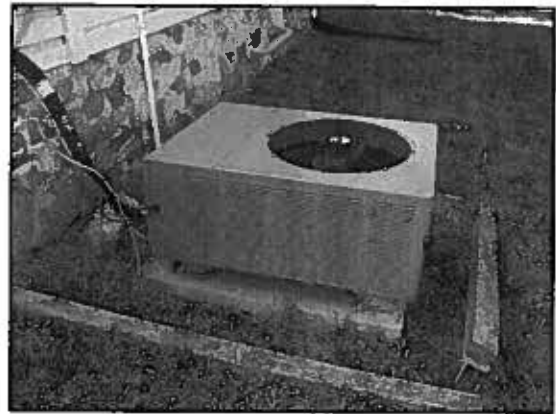
Heating and cooling are provided by a pad-mounted heat pump, located on the east side of the facility. The corresponding air handler with supplemental electric heat is located in the mechanical room on the ground floor. The cooling equipment uses R-22 as a refrigerant.

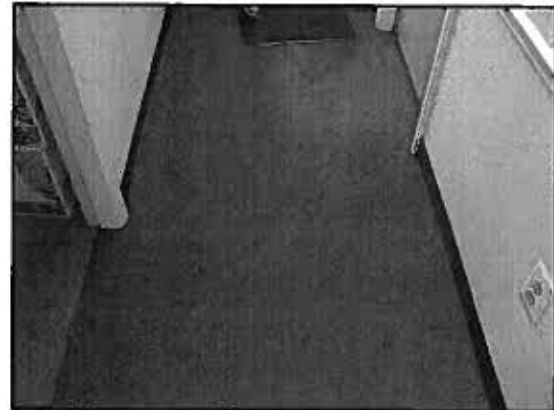
- The interior finishes in the tenant areas are in fair condition. Carpets are stained and worn. Since the areas are relatively small, and will be renovated at the same time as the common areas, the cost for the tenant area is included in Section 6.8 of this report
- The interior doors and door hardware are in good condition and will require routine maintenance during the assessment period.

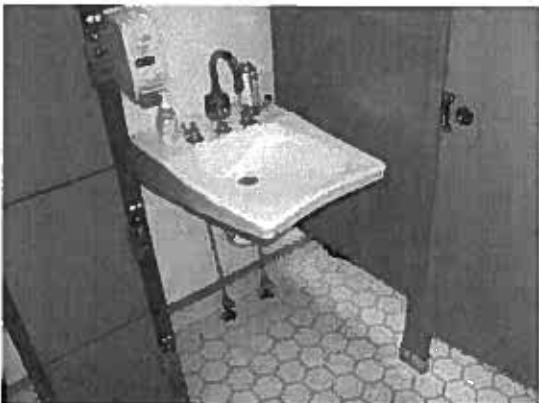
Photo #11: Compliant ADA bathroom
